FLOOD PLAIN INFORMATION

MERRIMACK — SHAWSHEEN — SPICKET RIVERS
LAWRENCE, METHUEN, ANDOVER &
NORTH ANDOVER, MASSACHUSETTS

PREPARED FOR LAWRENCE, METHUEN, ANDOVER & NORTH ANDOVER, MASSACHUSETTS BY
THE DEPT. OF THE ARMY, NEW ENGLAND DIV., CORPS OF ENGINEERS, WALTHAM, MASS.

MARCH 1972

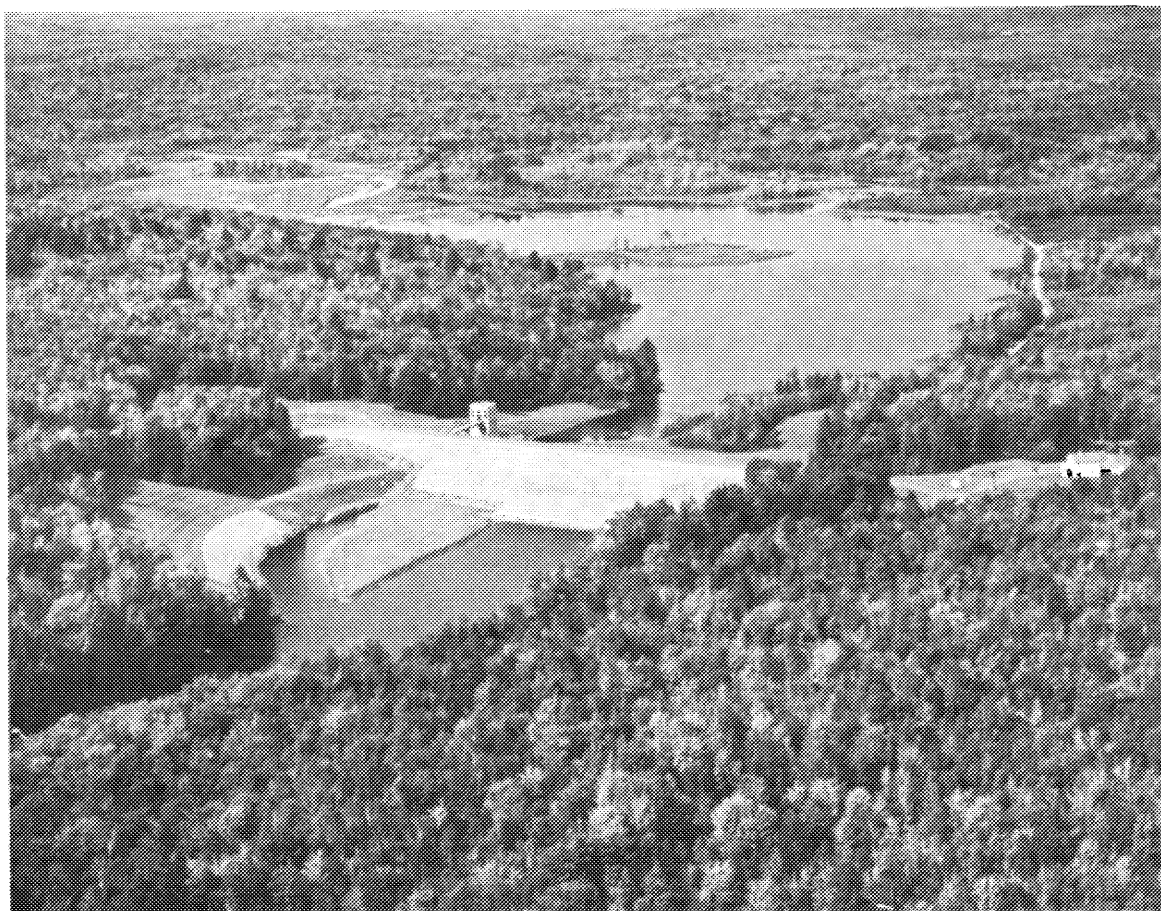
Edward MacDowell Dam

The reservoir is operated for flood control purposes and has a storage capacity of 12,800 acre-feet, which is equivalent to 5.5 inches of runoff from its drainage area of 44 square miles. The reservoir is normally kept empty. Control gates in the outlet works, located near the east side of the dam, are operated to store floodwaters in the reservoir during time of flood. When full, an 840-acre reservoir would extend about 9 miles upstream.

A concrete spillway, consisting of a low weir 100 feet in length, is located in a natural saddle on the north side of the reservoir. Discharges from this spillway go into Ferguson Brook which, in turn, discharges into the Contoocook River downstream from Peterborough.

The project provides flood protection for Peterborough and other communities in the upper Contoocook River basin. Integrated with other Merrimack River basin reservoirs, it also provides a measure of protection to damage centers on the lower Contoocook River. There have been 29 significant operations of storage, the largest, in terms of storage utilized, being that of January 1956 when the reservoir was 58 percent full. Total damages prevented since completion of the project have been \$470,000. With recurrence of the 1936 basin flood of record the project would prevent \$6.2 million in damages.

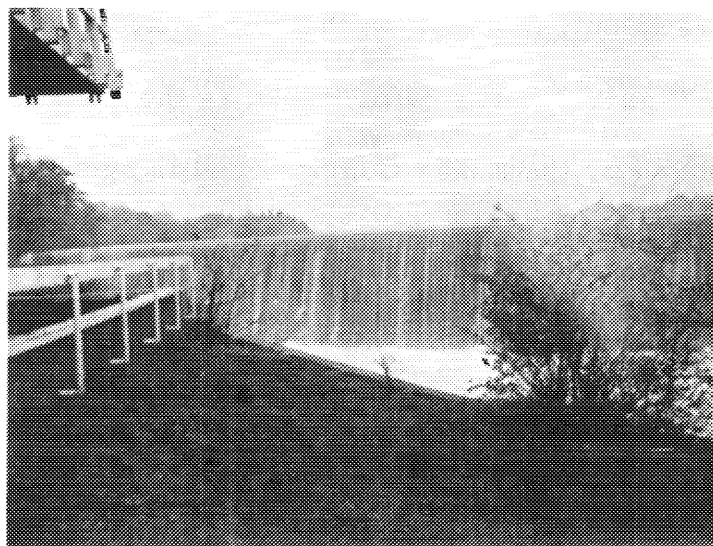
Essex Co. Dam - Merrimack River
(South End)

Records of river stages and discharges on the Merrimack River at Lawrence, Massachusetts have been maintained by the Essex Company at the Essex Company Dam since 1848.

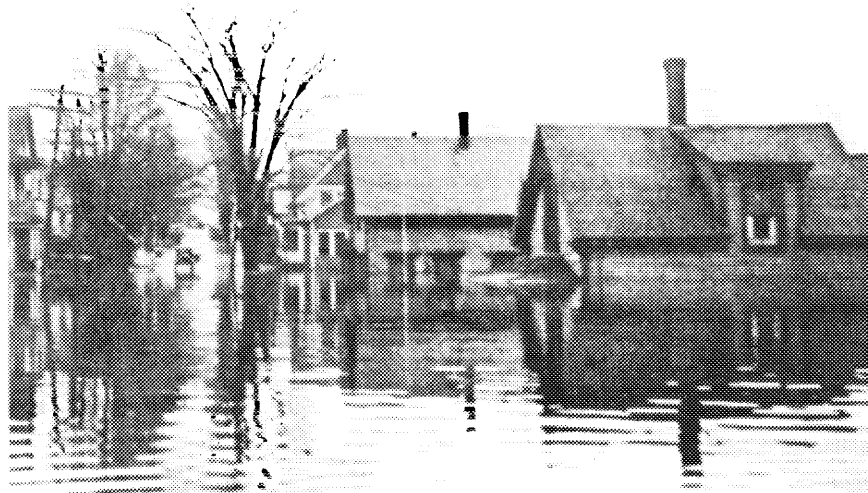
North Andover, Mass., March 21, 1936, 1:30 p.m.
Backwater on the Shawsheen River 700 feet from
the Merrimack River. View from boat above the
right-of-way of the B&M RR, looking southerly
along Beverly Street. H.W. elevation 44.0 feet.

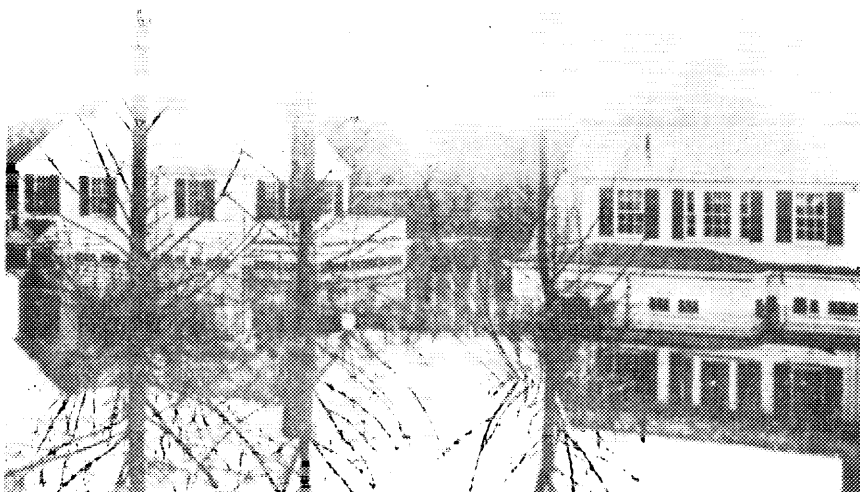
Shawsheen Village in Andover, Mass., March 21, 1936, 1:00 p.m. View just north of the Mall, from rear of Shawsheen Manor of the dwellings on Riverina Road. The Shawsheen River lies between the houses and the high land in the background. H. W. elevation 44.4 feet.

Shawsheen Village, which suffered considerable damage during the March 1936 flood, is still subject to flooding. (see Figure 23)
